CAVITATION EROSION RESISTANCE AND WEAR MECHANISMS OF ACTIVE SCREEN LOW TEMPERATURE PLASMA NITRIDED AISI 410 MARTENSITIC STAINLESS STEEL

Keywords: Expanded Martensite, Cavitation Erosion, Active Screen Plasma Nitriding, Mechanisms of Wear, Nanoindentation.

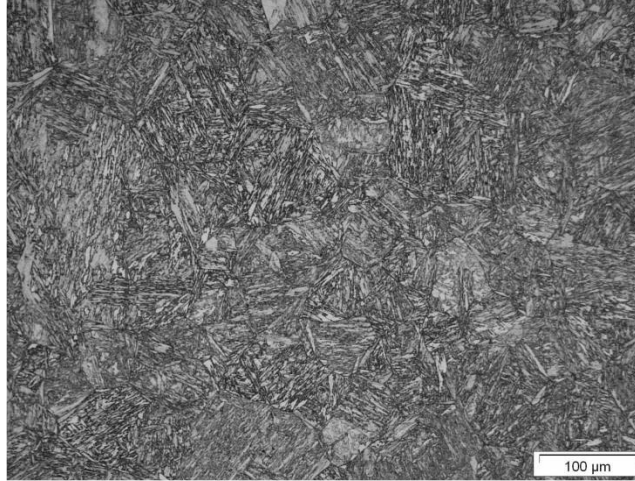
Figure 1 shows the microstructure of the quenched and tempered AISI 410, it can be seen that the microstructure is composed of tempered lath martensite as expected for the heat treatments conducted in this stainless steel. The average microhardness was 387 ± 7 HV0.01.

Figure 1 Quenched and tempered AISI 410 containing tempered lath martensite. OM image.

The active screen technique avoided crack formation and the massive precipitation of big iron nitrides observed in the first 5 μm deep region of the nitrided case obtained through conventional DC low temperature plasma nitriding of AISI 410, reported in a former work [5]. In addition, the microstructure of the nitrided case, shown in figure 3, remains almost the same in comparison with the original microstructure of the quenched and tempered AISI 410, shown in figure 1.

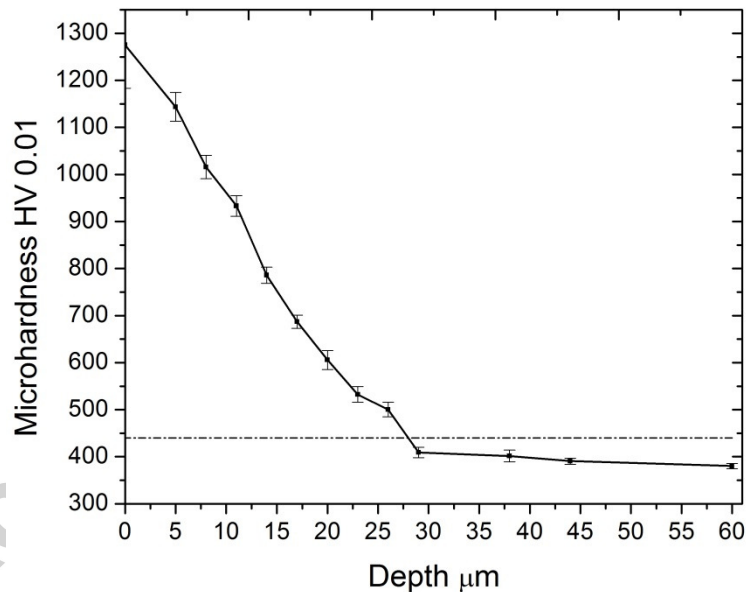
Figure 2 shows the microhardness variation as a function of depth for the nitrided specimen, together with the respective standard deviations.

Figure 2 Microhardness variation with depth of nitrided specimen.

The maximum hardness of 1275 ± 92 HV0.01 measured on the surface continuously decreases as a consequence of the reduction of nitrogen content with depth, till the hardness of the substrate is achieved. The microhardness gradient is very gentle throughout the nitrided case. According to the nitriding hardness depth – NHT criterion [19], the nitrided case is around 28 μm thick, as shown in figure 2.

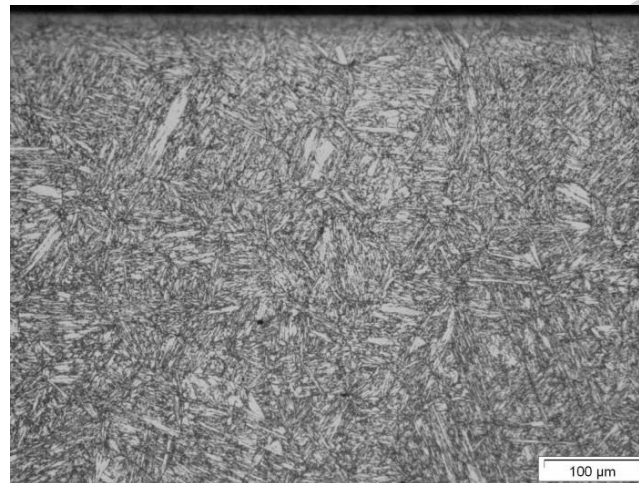
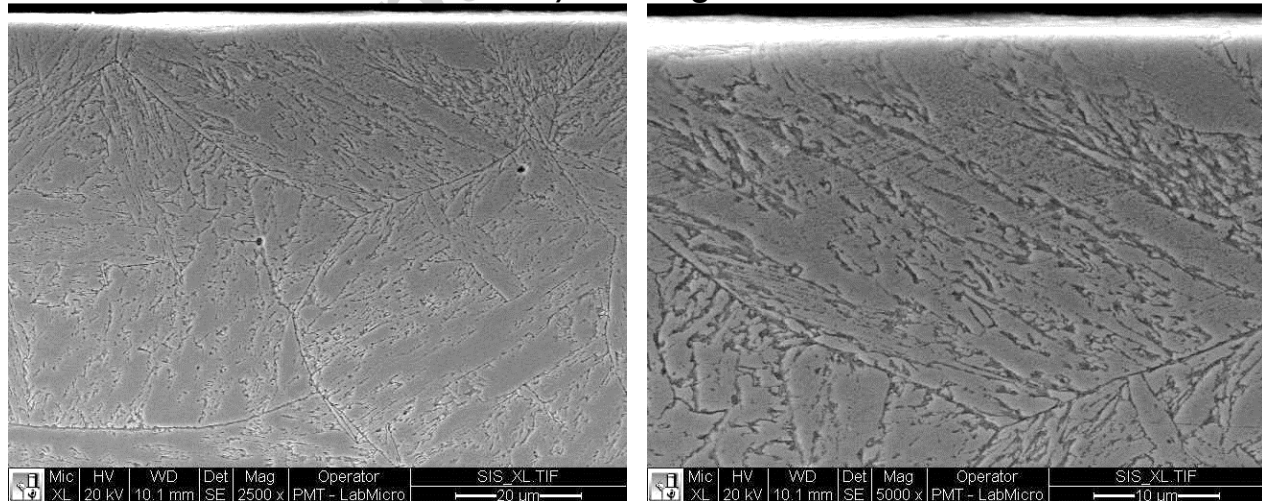
Figure 3 Cross-section view of the nitrided specimen, a) OM image, b) SEM images.

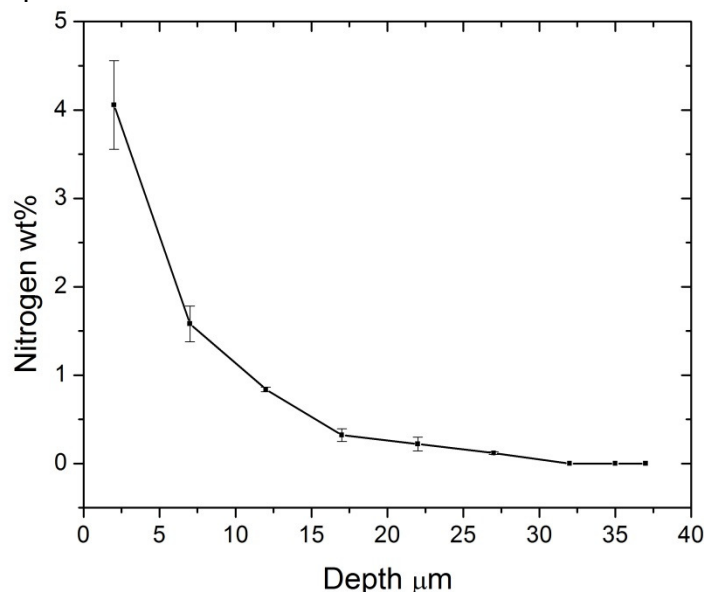
Figure 4 shows the nitrogen variation (wt. %) along the depth of the nitrided case together with the respective standard deviations.

Figure 4 Nitrogen variation along the depth of the nitrided case.

One can see in Figure 4 that the nitrogen content decreased from ~4 wt. % measured at 2 μm beneath the surface to ~0.1 wt. % at around 27 μm depth. These high nitrogen values are responsible for the increase in hardness of the nitrided specimen. It should be noted that the nitrogen content profile not only agrees with the gentle behavior of the microhardness profile, shown in figure 2, but also shows a similar value for the case depth, around 27 μm.

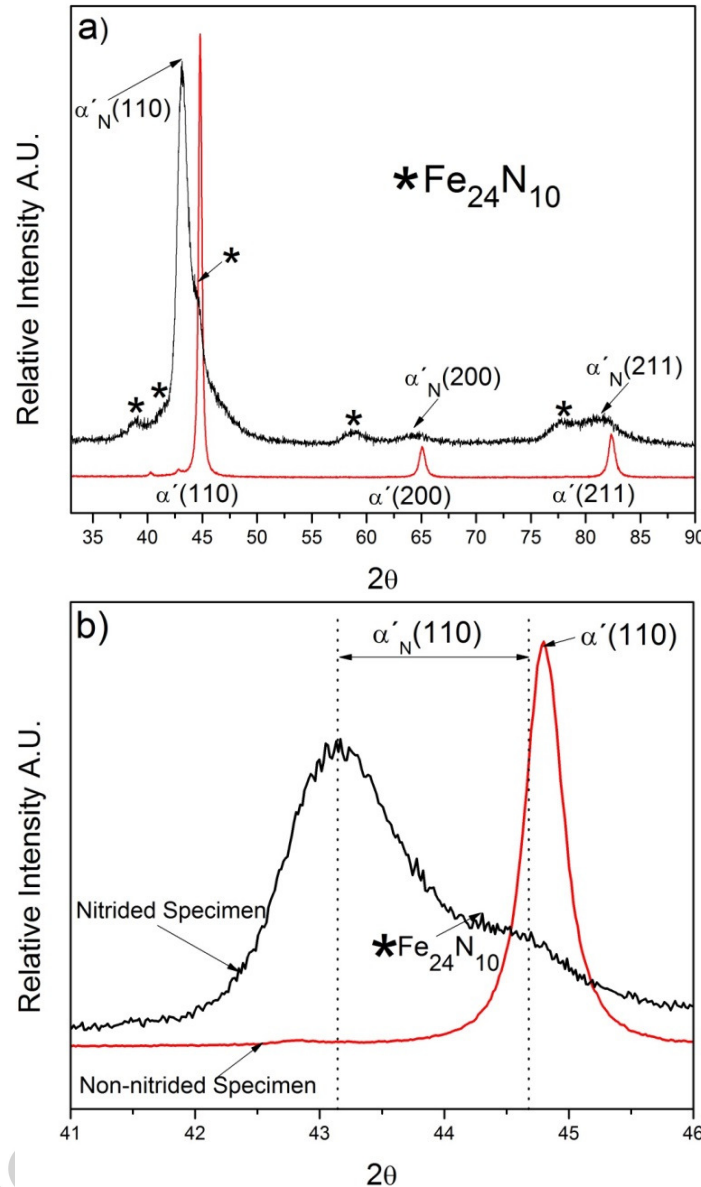
Figure 5 shows the X-ray diffraction patterns for both specimens. As can be seen in figure 5a, the non-nitrided specimen shows typical BCC martensite peaks (ICDD #06-0696) located at 2θ angles of 44.81 65.06 and 82.33. On the other hand, in the nitrided specimen those 3 martensite peaks were broadened and shifted to the left due to the nitrogen gradient along the nitrided case, which produced a different lattice parameter (interplanar spacing) as a consequence of the different nitrogen amounts dissolved at the interstitial sites of the crystal structure. It should be noted that part of the expansion is due to development of compressive stresses in the nitrided case [23]. The peaks located at 2θ angles of 43.12 64.11 and 81.60 correspond to a nitrogen supersaturated phase, known as expanded martensite. The $\alpha'_N(110)$ expanded martensite region of the X-ray pattern lies between 43.12° and 44.66°, as shown in Figure 5b, indicating a nitrogen gradient inside the nitrided case. This conclusion is supported by the microhardness gradient shown in Figure 2, the microstructure shown in figure 3 and the nitrogen gradient measured in the nitrided case shown in Figure 4. In addition to the expanded martensite peaks, the nitrided specimen diffraction pattern shows hexagonal ϵ -Fe₂₄N₁₀ iron nitrides peaks (ICDD #73-2103), structurally similar to ϵ -Fe₃N.

Figure 5 X-ray diffraction patterns for nitrided and non-nitrided specimens.

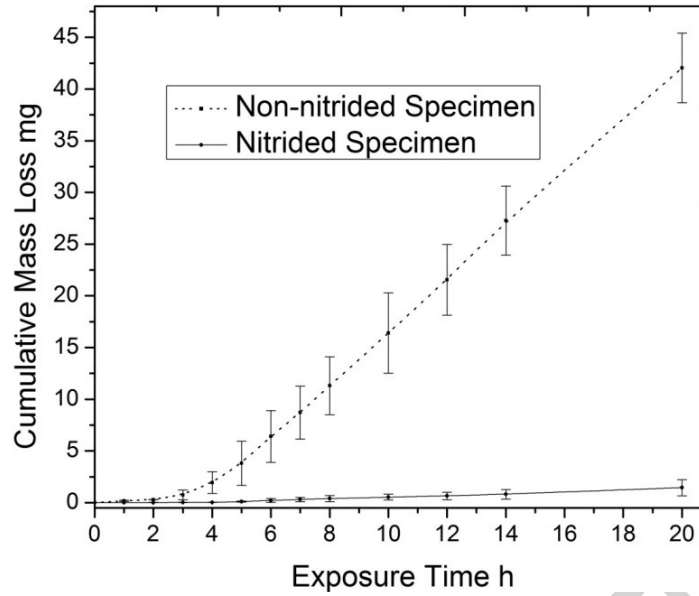
Cumulative mass losses variations as a function of exposure time are shown in figure 6. The scatter bars comprise one standard deviation.

Figure 6 Cumulative mass losses variations as a function of exposure time for nitrided and non-nitrided specimens.

After 20 hours of testing, the non-nitrided specimen lost ~42 mg and the nitrided specimen lost ~1.5 mg. The nitrogen addition decreased 27 times the mass loss of the quenched and tempered AISI 410. The erosion rates were calculated from the slope of the straight line plotted from the fifth hour on, as shown in figure 6, accordingly, the erosion rates were 0.085 mg/h and 2.56 mg/h for nitrided and non-nitrided specimens, respectively.

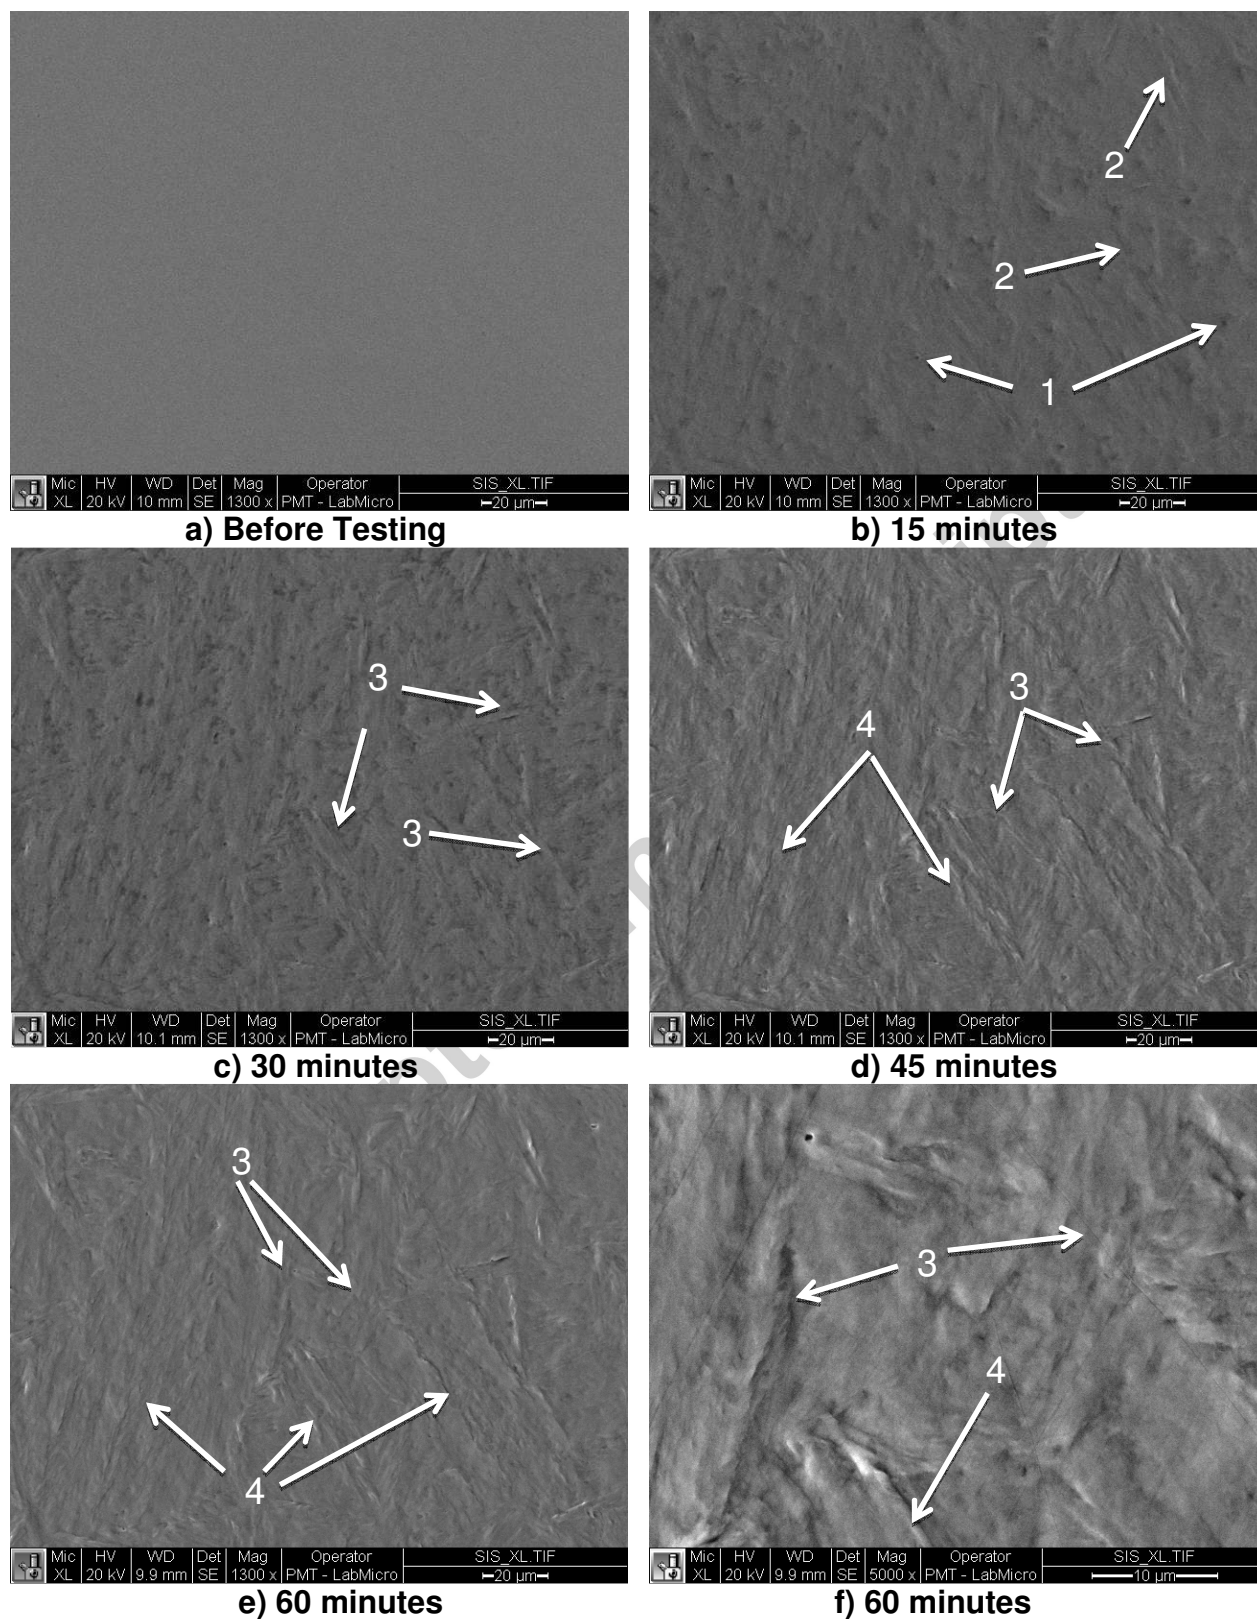
Figure 7 shows the evolution of the damage during the first hour of testing in non-nitrided specimen. Prior to the cavitation test, the surface was ground with emery papers up to ASTM 1,200 and then polished with 6, 3 and 1 μ m diamond paste.

Figure 7 Evolution of the damage during the first hour of testing in non-nitrated specimen, a) before testing b) 15 minutes of testing, c) 30 minutes of testing, d) 45 minutes of testing, e and f) 60 min. SEM images.

It can be seen from figure 7b) that a significant change occurs at the surface within the first few minutes of testing: a slight relieve was created due to the formation of very small pits (1) and smooth grooves (2), indicating that the surface is undergoing plastic deformation. In figure the sequence 7c to 7f it may be seen that the grooves revealed prior austenitic grain boundaries (3), delineated due to material flow. In addition, martensite lath boundaries (4) were also revealed, as a consequence of plastic deformation. At this time, the mass loss was very low (~0.19 mg) and the main damage at the surface was plastic deformation.

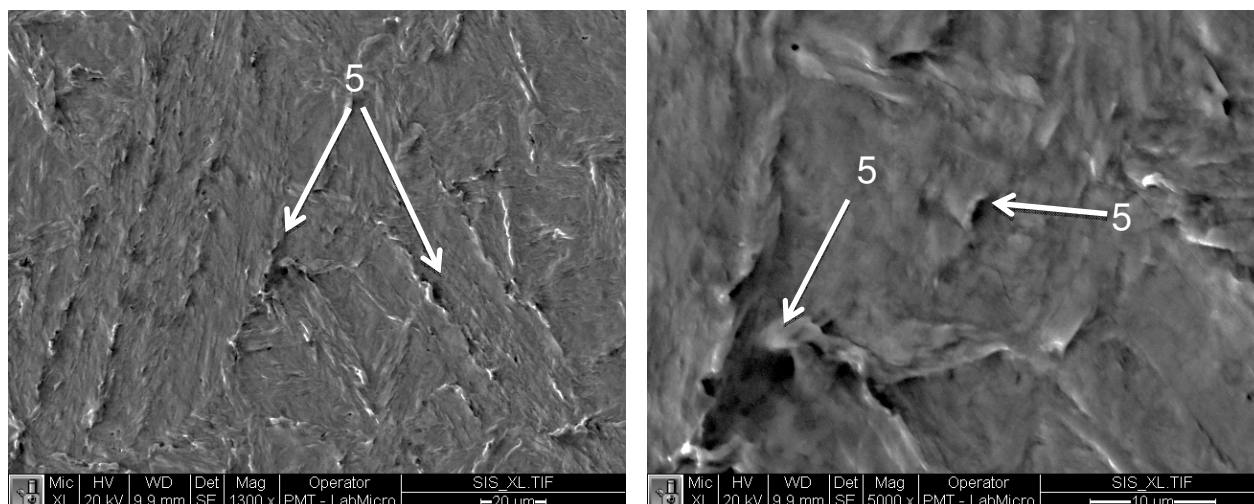
Figure 8 Cavities (5) and surface steps created due to mass accumulation at twins and grain boundaries after 120 minutes of testing. SEM images.

Plastic deformation increases and cavities (5) are formed along martensite lath boundaries and prior austenite grain boundaries. Furthermore, lath boundaries and grain boundaries act as barriers to material flow, causing an accumulation of strained-mass at these imperfections, creating protruding lips on the surface, shown in figure 8.

After 120 minutes of testing, the cumulative mass loss is around 0.30 mg indicating that some material was detaching from the protruding lips. Moreover, one can see that detachment of particles from these lips occurred mainly by a ductile mechanism, leaving very thin walls due to necking. In the interval between 150-180 minutes, the surface appearance strongly changed due to removal of the protruding lips, as shown in figure 9. Cavitation damage occurred by plastic deformation, possibly by fatigue and finally by ductile fracture mechanisms. The cumulative mass loss after 180 minutes of testing was ~0.75 mg.

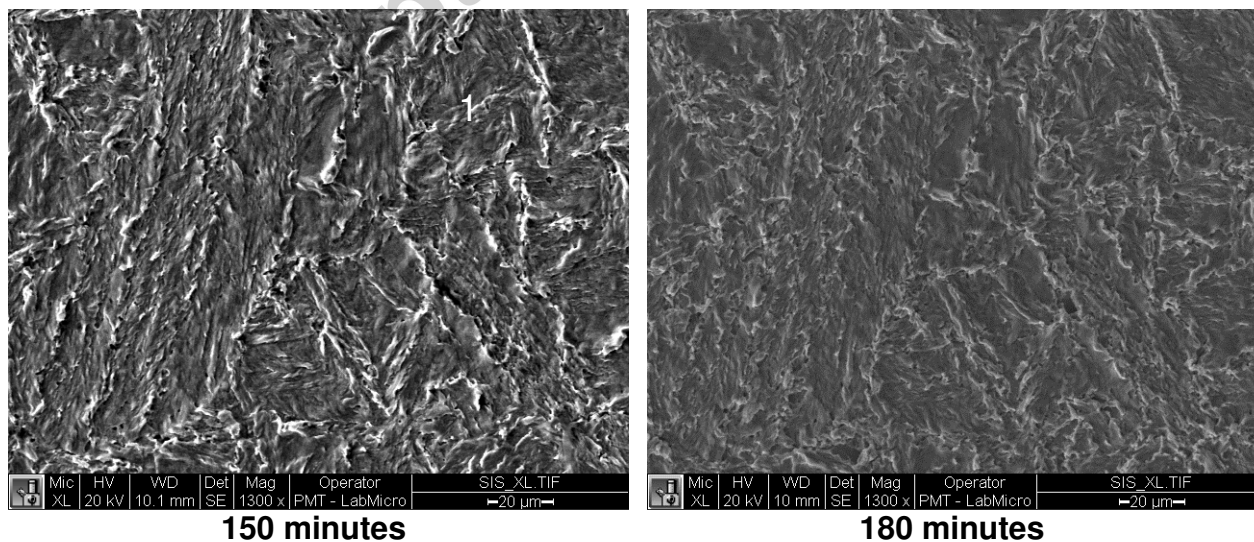
Figure 9 Material detachment from the strained mass accumulated at protruding lips, due to a ductile fracture mechanism within 150 – 180 minutes of testing. SEM images.

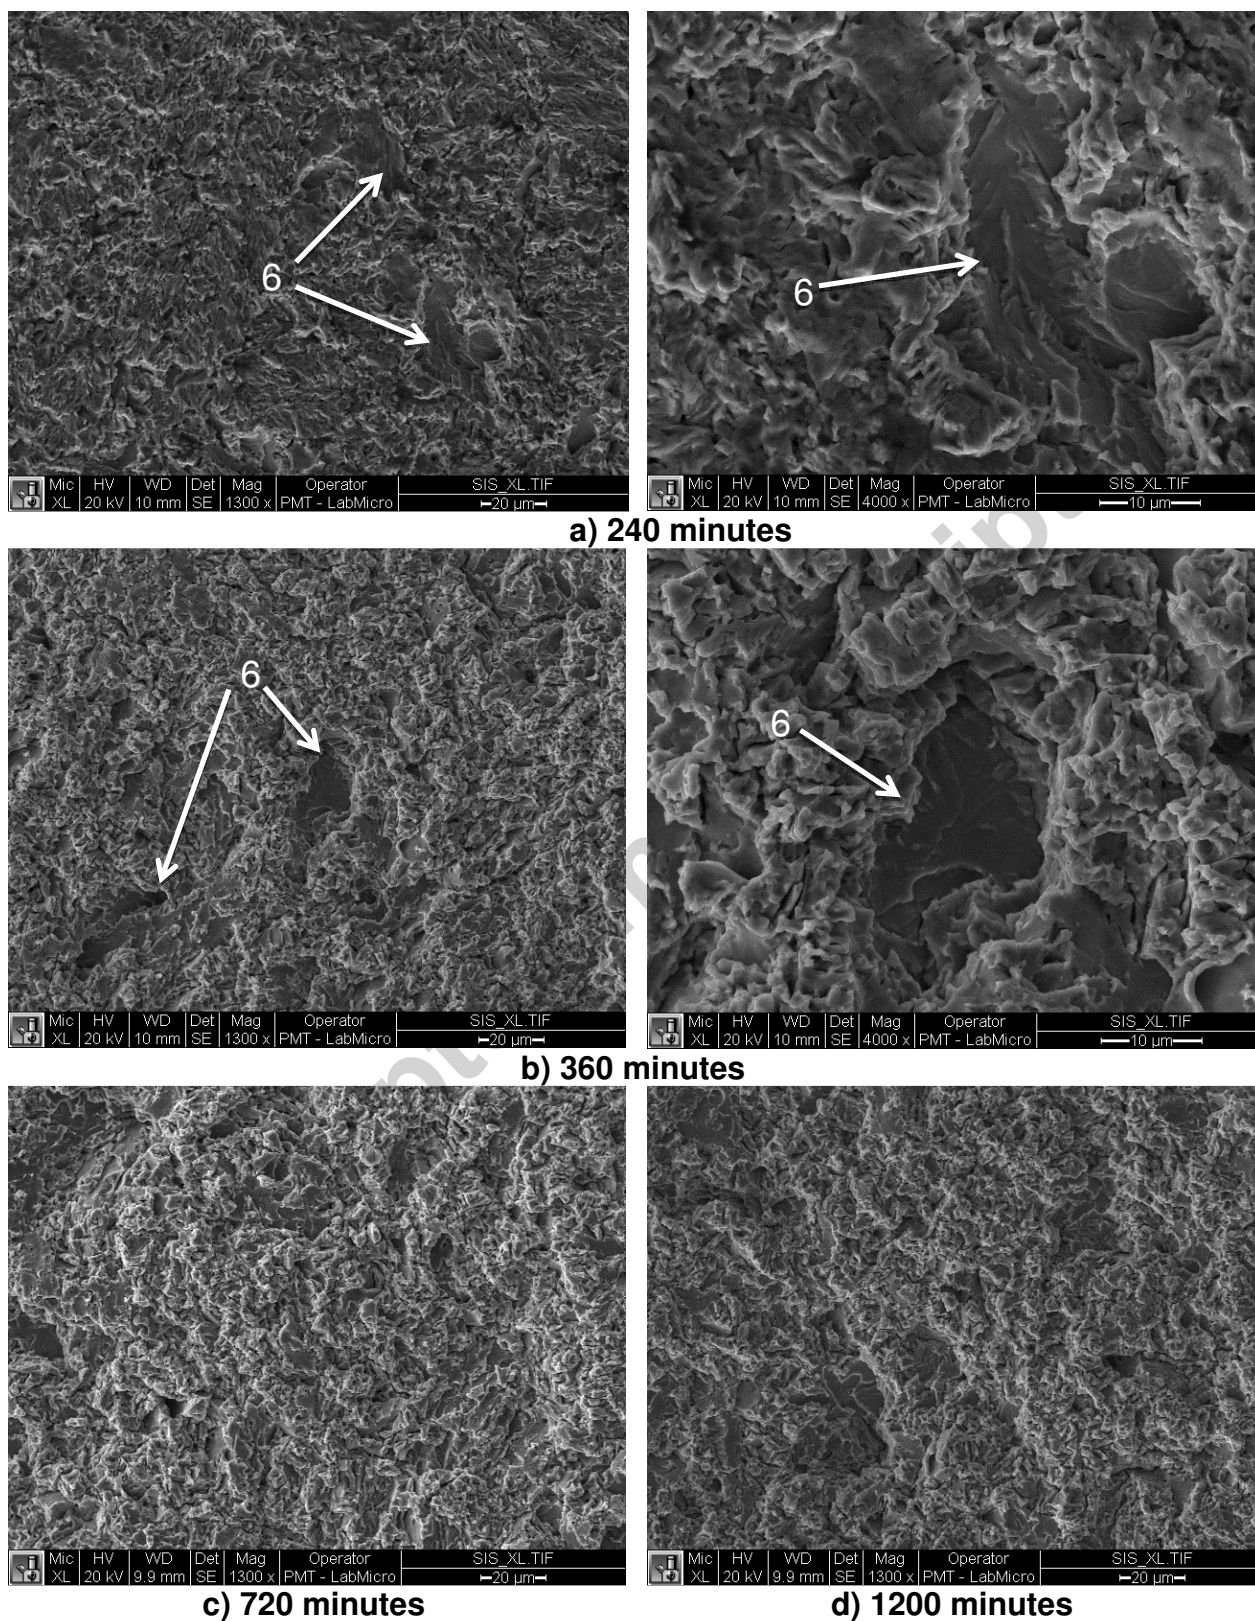
Figure 10 Material detachment due to cleavage from ~180 minutes of testing until the end of the test, a) 240 minutes of testing, b) 360 minutes of testing, c) 720 minutes of testing and d) 1200 minutes of testing. SEM images.

However, from 180 minutes of testing on, it seems that the non-nitrided specimen changed from ductile to brittle behavior. Most probably, due to the presence of small cavities on the surface, the shock waves induced more complex states of stresses, changing the mechanical behavior of the deformed surface from ductile to brittle. Consequently, cracks are able to propagate rapidly by cleavage (6) without significant plastic deformation. The non-nitrided specimen showed this brittle response until the end of the test, as shown in figure 10.

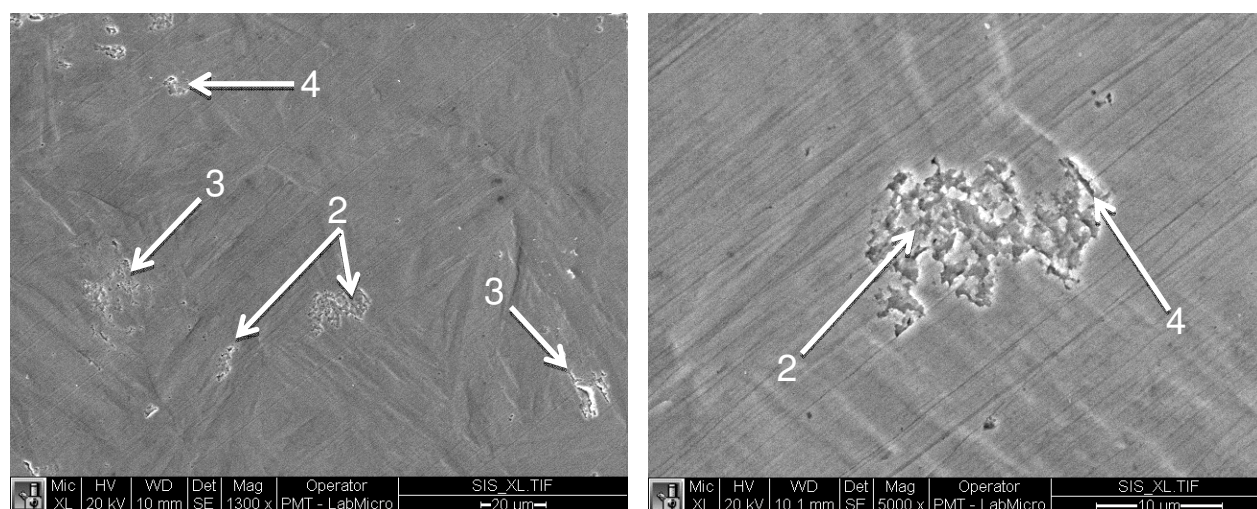
Figure 12 New pores nucleation in other grains (3) and at grain boundaries (4) after 105 minutes of testing. SEM images.

During the first 60 minutes of testing, some tiny pores (1) appeared inside some grains; but, generally speaking, the nitrided specimen surface did not show any significant change and most of the grains remained intact, supporting the fact that the expanded martensite elastically absorbed the shock-waves impact, without plastic deforming. After 105 minutes, the number of pores inside the grains was increased (2) and new pores were nucleated, not only in other grains (3) but also at grain boundaries (4), as can be seen in figure 12.

Furthermore, it can be seen in figure 12 that the damage inside the grain was nucleated at the martensite lath boundaries.

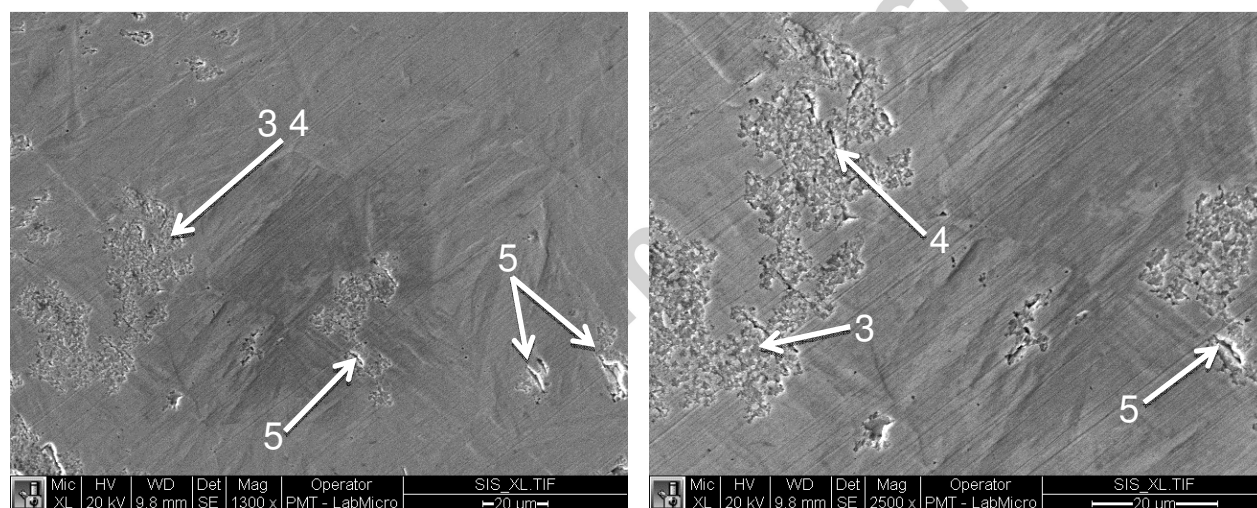
Figure 13 Increase on pores nucleation within grains and at grain boundaries after 180 minutes of testing. SEM images.

The pores nucleation process, along the surface within grains and at grain boundaries, increased with the exposure time, wear particles were detached from the surface, as can be seen for 180 and 300 minutes of testing time in figures 13 and 14 respectively. Moreover, some former pores increased their size and depth, becoming craters (5), particularly those located at martensite laths. It can be inferred that the material removal is due to brittle fracture without plastic deformation.

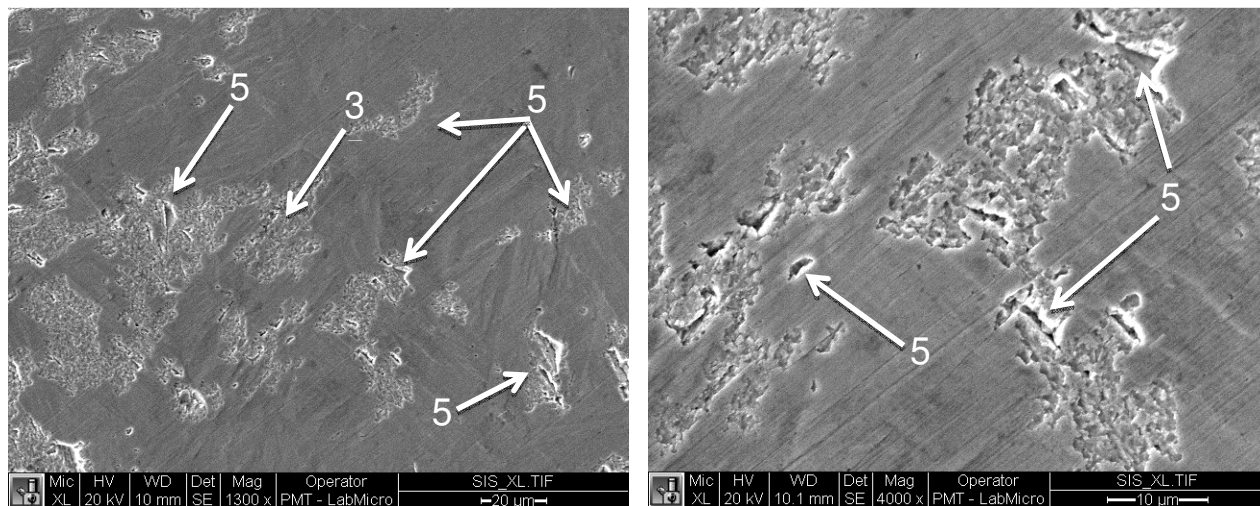
Figure 14 Increase on pores nucleation within grains and at grain after 300 minutes of testing. SEM images.

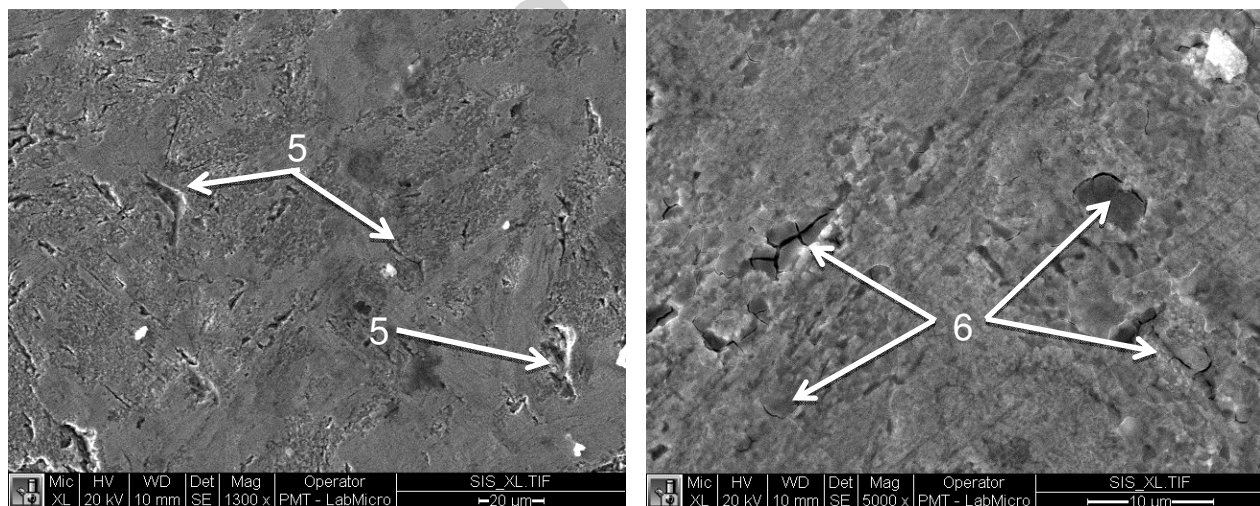
Figure 15 Surface appearance of the nitrided specimen after 600 minutes of testing. SEM images.

Pores nucleation and growth proceeded and spread over the entire surface till around 600 minutes of testing, as shown in figure 15. The original surface was completely removed, but grain boundaries and craters are still observed. The nitrided case shows a brittle behavior and some cracks (6) nucleated inside the craters. At this time the cumulative mass loss was ~ 0.54 mg, indicating that mass removal occurs in a thin layer at the surface instead of penetrating deeper regions; in other words, the erosion penetration depth into the nitrided specimen was very low.

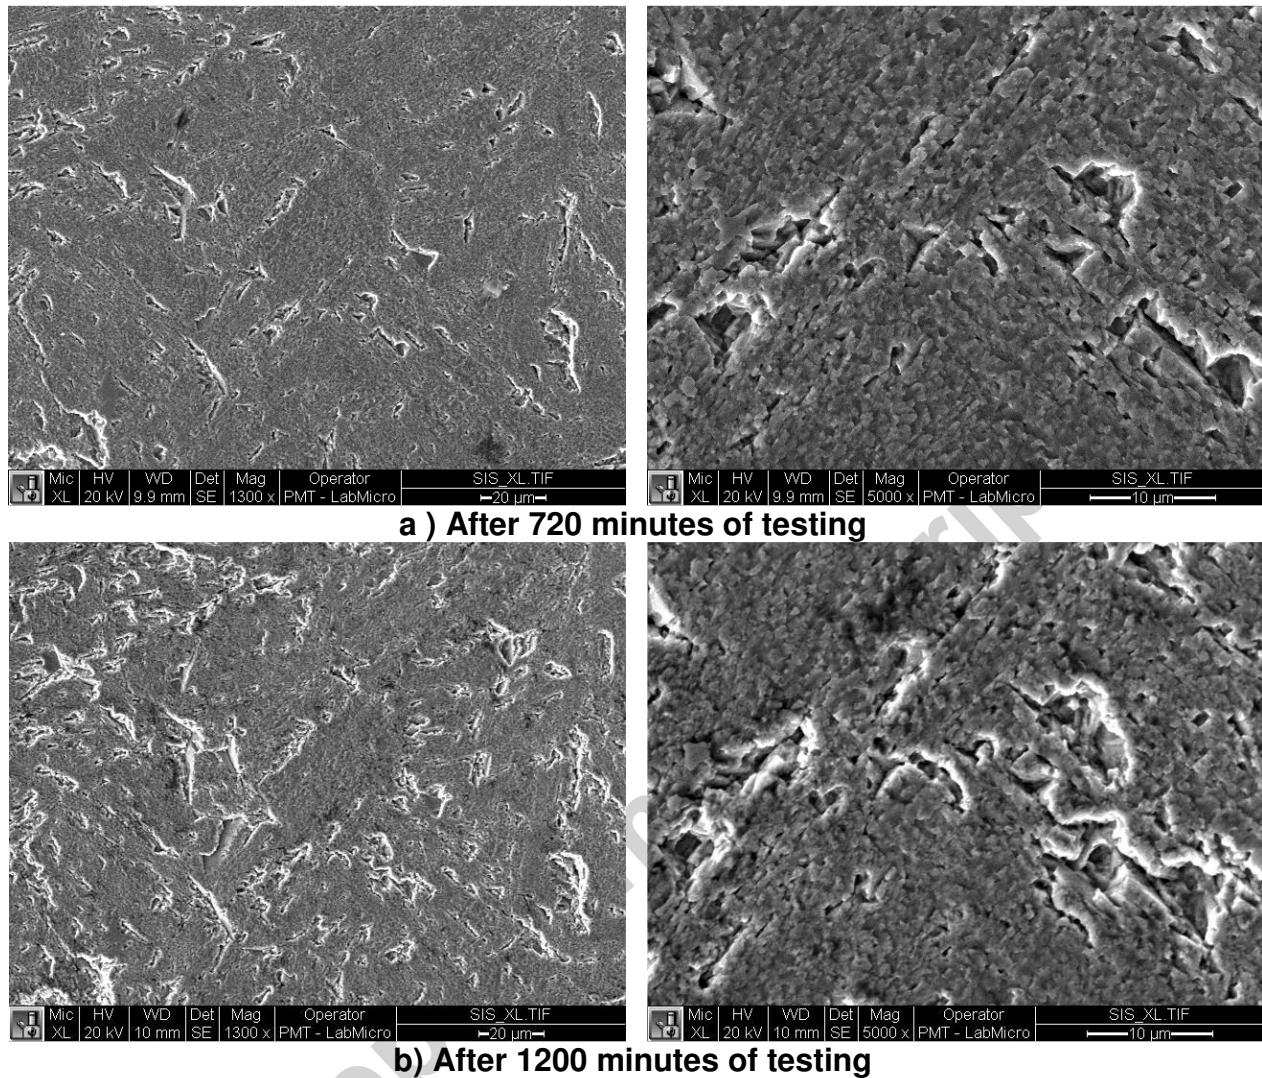
Figure 16 shows the evolution of the damage at 720 and 1,200 minutes of testing. The wear mechanism remained unchanged along the test. New craters were formed; the nitrided specimen continued losing mass from the craters and by debris detachment from the grains surfaces, due to brittle fracture, without evident plastic deformation.

Figure 16 Nitrided specimen surface, a) after 720 minutes of testing and b) after 1200 minutes of testing. SEM images.
